CAMERON AML PROJECT No. 1

NOMINATION FOR 1993
NATIONAL ABANDONED MINE LAND RECLAMATION AWARD

NOMINATION OF ABANDONED MINE LAND RECLAMATION PROJECT CAMERON AML PROJECT No.1

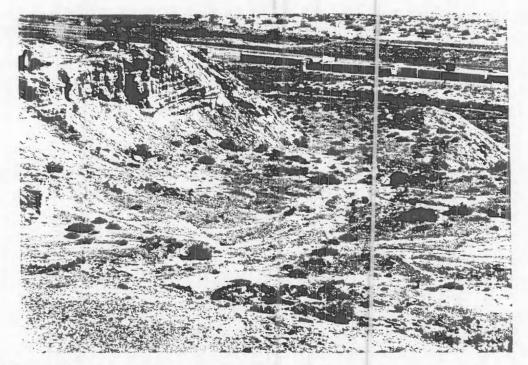
PHOTOGRAPH NO. 1: NA-0155a - Henry Sloan No. 1 - Lower terraced rimstrip with roadside vendor stands along US 89 in background.

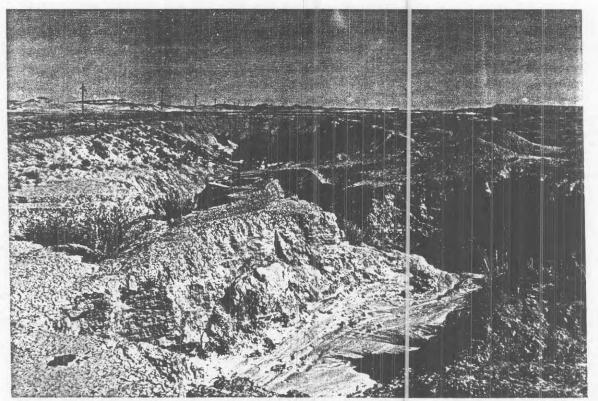
PHOTOGRAPH NO. 4: NA-0113 Jeepster No. 1 - Photograph shows open pit and erosion caused by runoff from wastepile into pit.

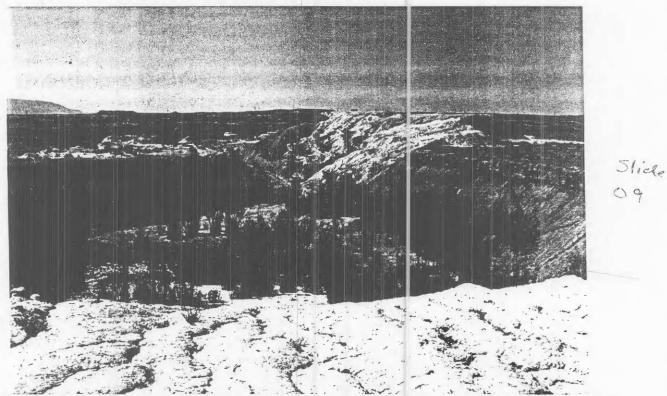
PHOTOGRAPH NO. 6: NA-0123 Charles Huskon No. 19 - Another view (looking to the west) of pit. US 89 is in the background.

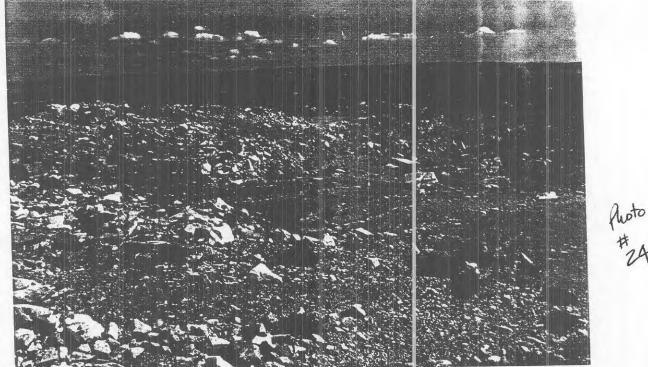
PHOTOGRAPH NO. 7: NA-0125 Charles Huskon No. 12 - Photograph shows site with homes in the background.

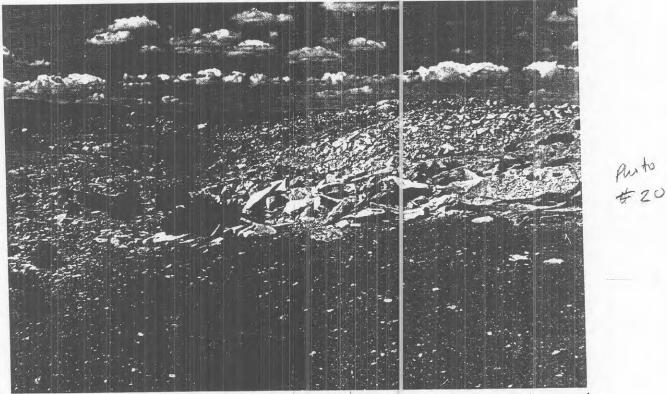
PHOTOGRAPH NO. 8: NA-0125 Charles Huskon No. 12 - Photograph shows site looking to the west.

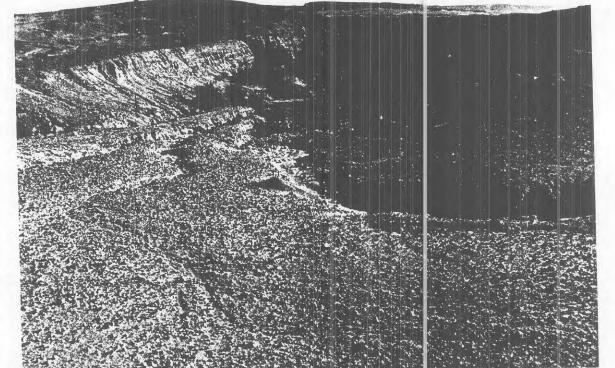
PHOTOGRAPH NO. 9: NA-0141 Juan Horse No. 4 - Photograph shows open pit, high walls, and wastepiles on left and right.

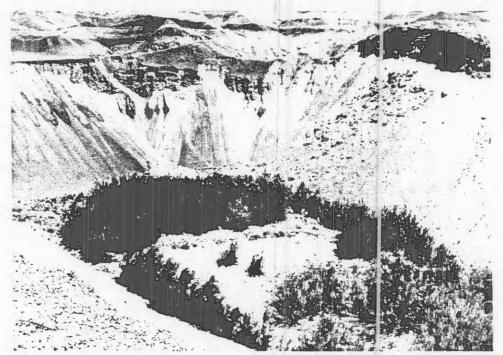
PHOTOGRAPH NO. 11: NA-0148 Jack Huskon Nc. 3 - Photograph shows open pit with impounded water and highwalls. Background is badlands topography associated with the Painted Desert.

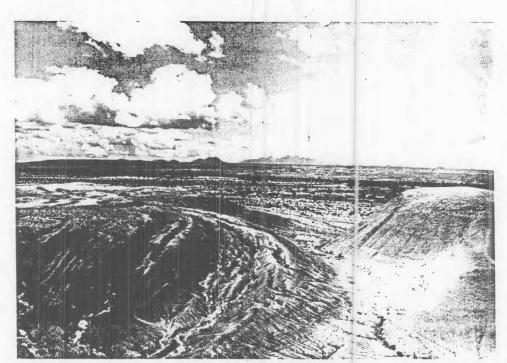
PHOTOGRAPH NO. 12: NA-0148 Jack Huskon No. 3 - photograph shows erosion in wastepile caused by runoff. In the background is the San Fransico Peaks, approx. 45 miles away and nearer is the Little Colorado River.
